Manhole Inspection Summary

Manhole # S31E__025MH

Location Address: **side 513 w lexington st**

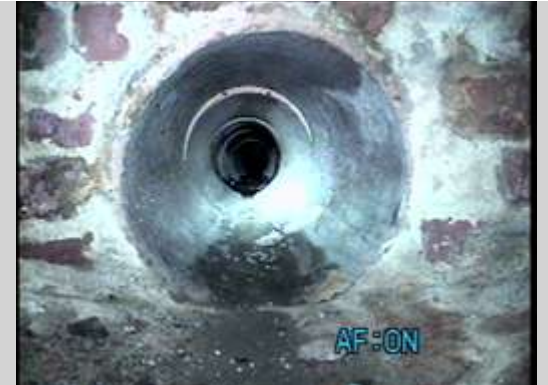
12 O'Clock Outflow

8 in. Circular Gravity Sewer
Pipe Out @ 12 O'Clock

Pipe Material: **Clay** ☐ Pipe Lined

Infiltration: **None** Pipe Seal Cond: **Unknown**
